SA Leak Detection Distributors

## Life Anncron Hospital, Klersdorp, South Africa.

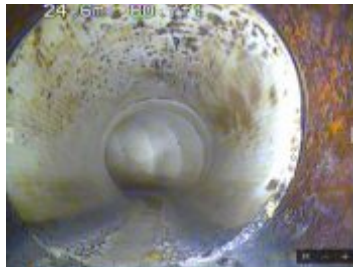
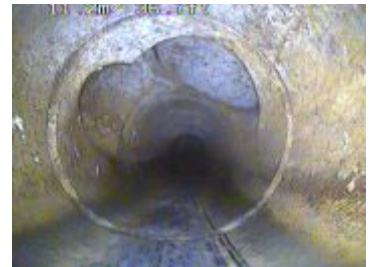
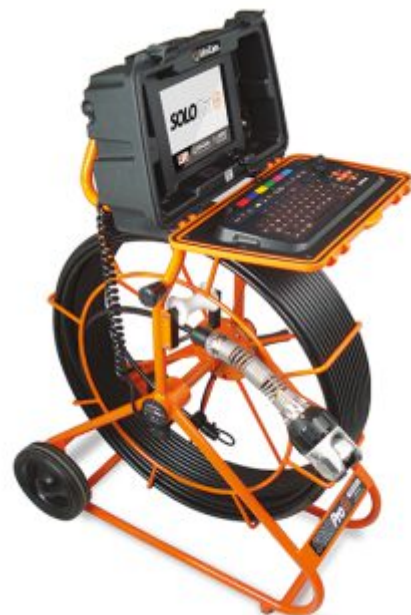
**System:** Orsco used a Mini-Cam SoloPro CCTV pipe inspection camera to inspect 28.2 meters of 160mm earthenware and PVC pipe. Orsco came across a problem at 24.6 meters at a connection where the pipe changes from earthenware pipe to PVC. At this section, Orsco was able to determine the source of the problem, the pipe was connected without using an earthenware convertor to PVC. The PVC pipe was simply stuck into the earthenware pipe without a proper fitting leaving a gap and not sealing correctly. Orsco provided the hospital with a detailed report showing the problematic joint.
